Full scale testing of wind turbine blade to failure - flapwise loading

Abstract A 25m wind turbine blade was tested to failure when subjected to a flapwise load. With the test setup, it was possible to test the blade to failure at three different locations.

The objective of these tests is to learn about how a wind turbine blade fails when exposed to a large flapwise load and how failures propagate.

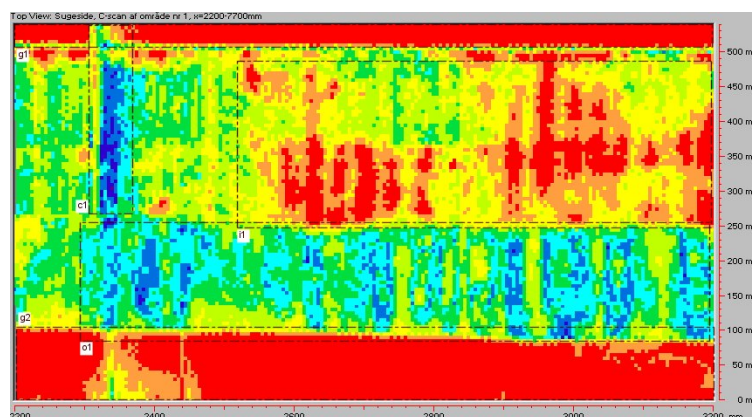
Figure 3 Ultrasonic scan from 2.2m to 3.2m (section 3)

In this scan a good adhesion between the layers is seen, even though there are areas (marked i1, red), which indicates missing adhesion or epoxy. In this scan red "lines" are seen in upper right part of the figure, which indicates how the epoxy is put in lines during manufacturing of the blade. In other areas these lines where much more dominant and larger areas with a bad adhesion/distribution of epoxy was also seen in some areas.

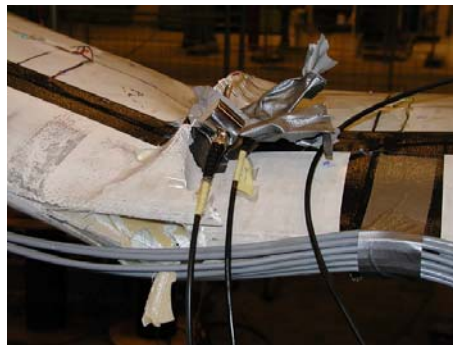
In test of section 1 (19.3m to 23.3m) the blade failed 20.1m from the root, with a load introduction as given in figure 4. In the figures below the large deflection in this test is seen as well as a picture of the failed section of the blade.

Figure 8 The blade failed 20.1m from the root section. AE sensors where mounted very close to the failure
